# **Non-destructive Evaluation of Aircraft Structural Components and Composite Materials at DSTO Using Sonic Thermography**

***Kelly A. Tsoi and Nik Rajic***

**DSTO–TN–0986**

## **ABSTRACT**

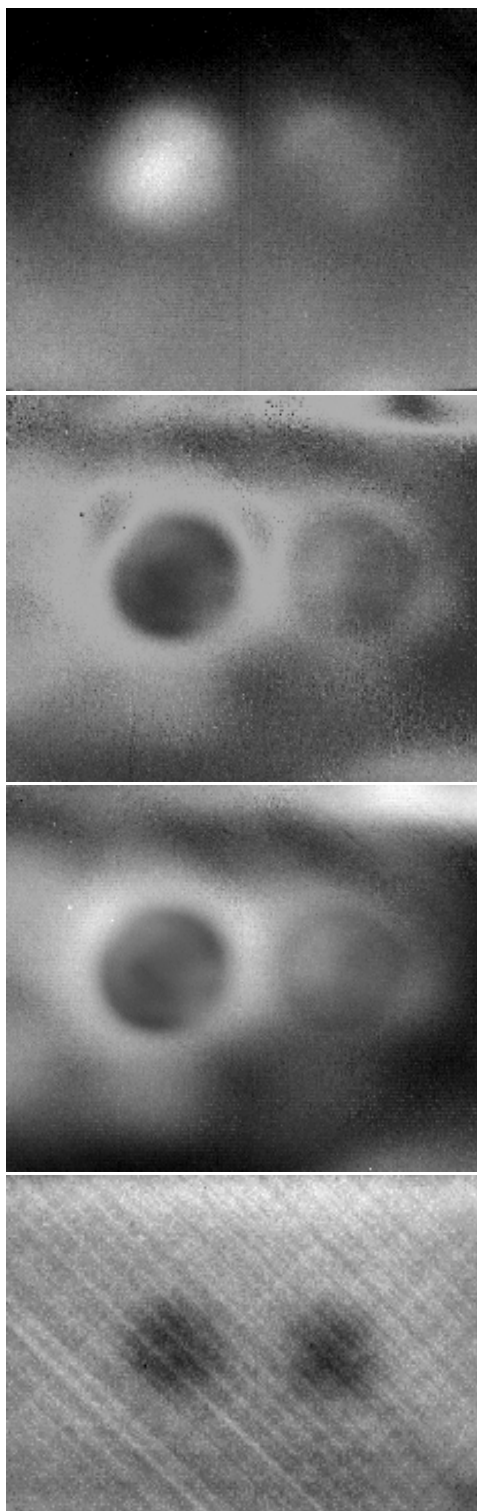
**Figure 3:** From top to bottom, ST raw, PPT and  $PCT_2$  results and flash PPT showing signatures from the Teflon inserts.

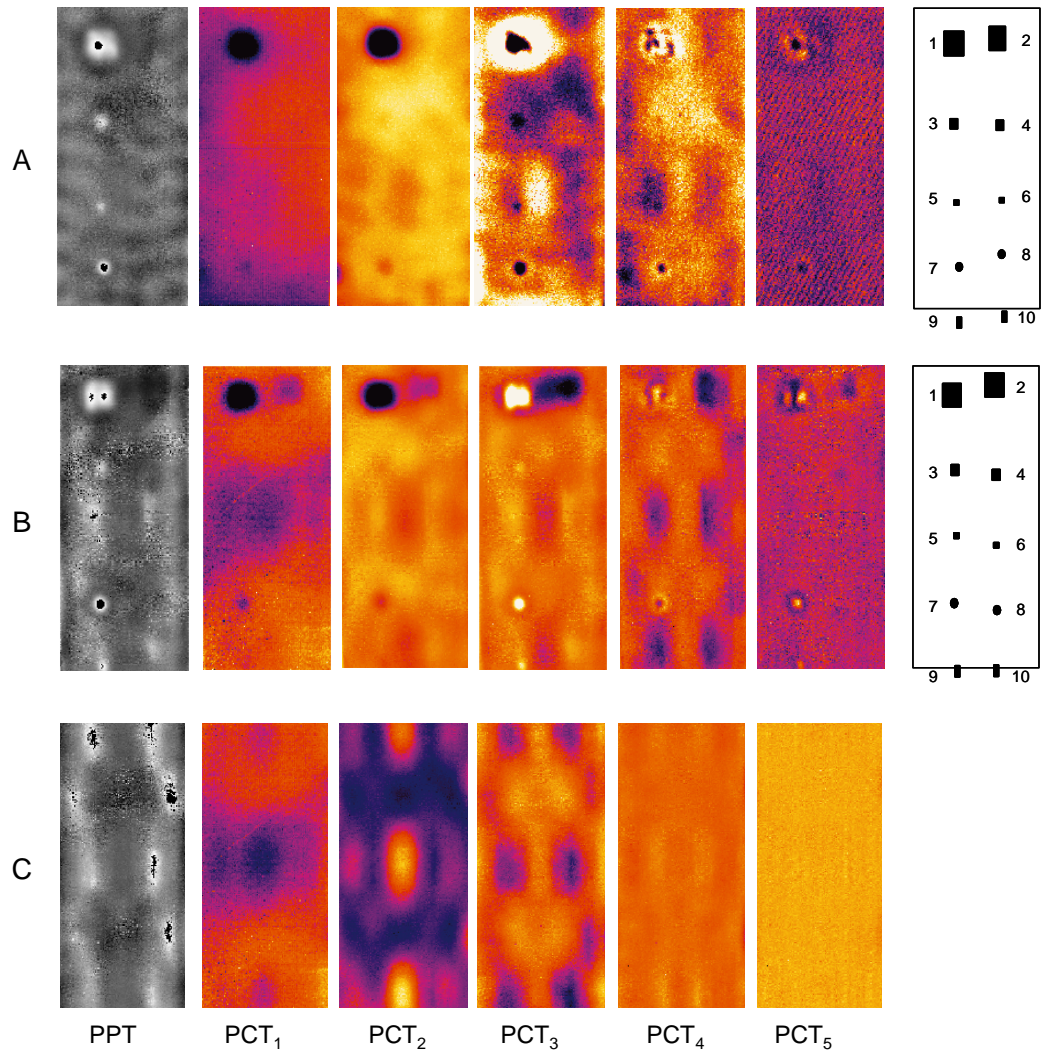
Figure 5 shows the PPT and PCT results for the ST inspection of specimens A, B and C. The PCT results show the first five modes. The PPT results for specimens A and B show strong indications for inserts located at a depth of 15% below the surface. For both specimens A and B, all modes show indications of inserts 1 and 7. Modes 2, 3, and 4 (PCT<sub>2</sub>, PCT<sub>3</sub> and PCT<sub>4</sub>) show indications of the inserts embedded at 15%. For the inserts embedded in the midplane, there appears to be no indication for specimen A, however for specimen B defects 2, 4 and 8 are observable in PCT<sub>5</sub>. Specimen C shows vibration modes set up within the specimen due to the acoustic excitation. These are distinguished from structural defects by the distinctly periodic pattern of the signature, which effectively maps the anelastic strain amplitude in the specimen. Interestingly, while specimen B produces a modal pattern similar to that of specimen C, specimen A yields a different pattern. This could be a result of slight variations in laminate thickness, variations in the defect geometry or acoustic horn position during insonification.

**Figure 5:** ST inspection of the thin film insert specimens from front face. Specimens A, B and C are indicated, and the PPT and PCT<sub>1-5</sub> results, are shown. The defect positions for specimens A and B are shown to the right of the thermographs.

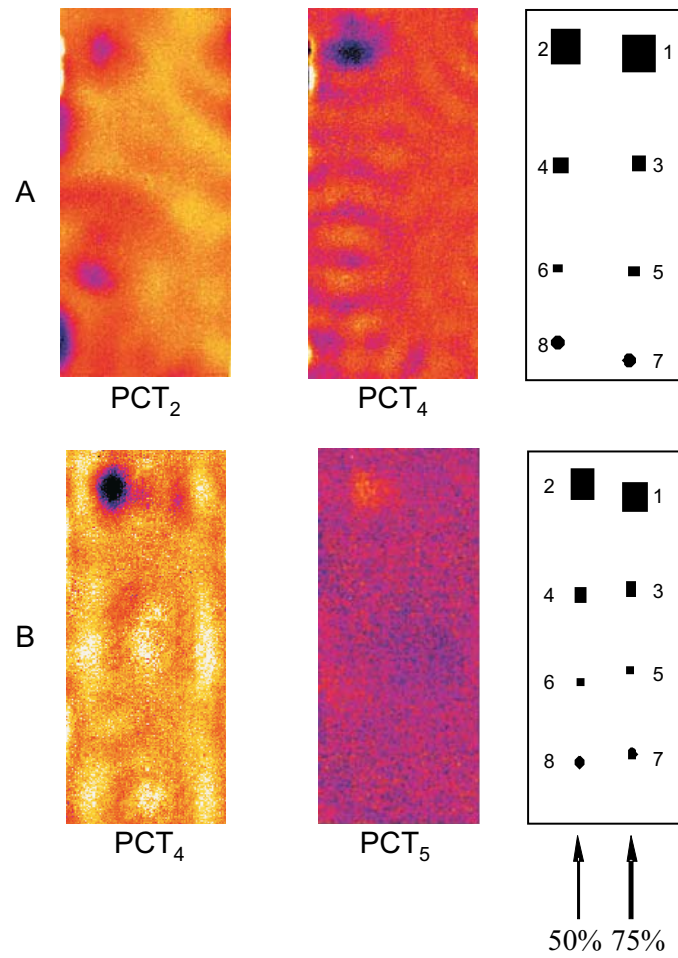
Figure 7 shows the ST inspection of the reverse side of the specimens, in which defects located 0.9 mm beneath the surface are now located at 5.1 mm below the surface. Only PCT<sub>2</sub> and PCT<sub>4</sub> for specimen A and PCT<sub>4</sub> and PCT<sub>5</sub> for specimen B are shown. From these results it can be observed that for specimen A, defects 2 and 6, in the midplane, which were previously not observable, are now detectable in PCT<sub>2</sub> and defect 2 alone in PCT<sub>4</sub>. For specimen B, defect 1, at 5.1 mm and defect 2, at 3 mm below the surface, are observable in the PCT<sub>4</sub> and only defect 2 is observable in the PCT<sub>5</sub> results.

**Figure 7:** ST inspection of the reverse face of the thin film delamination specimens showing PCT<sub>2</sub> and PCT<sub>4</sub> results for specimen A and PCT<sub>4</sub> and PCT<sub>5</sub> results for specimen B as indicated. The defect positions for specimens A and B are shown to the right of the thermographs.

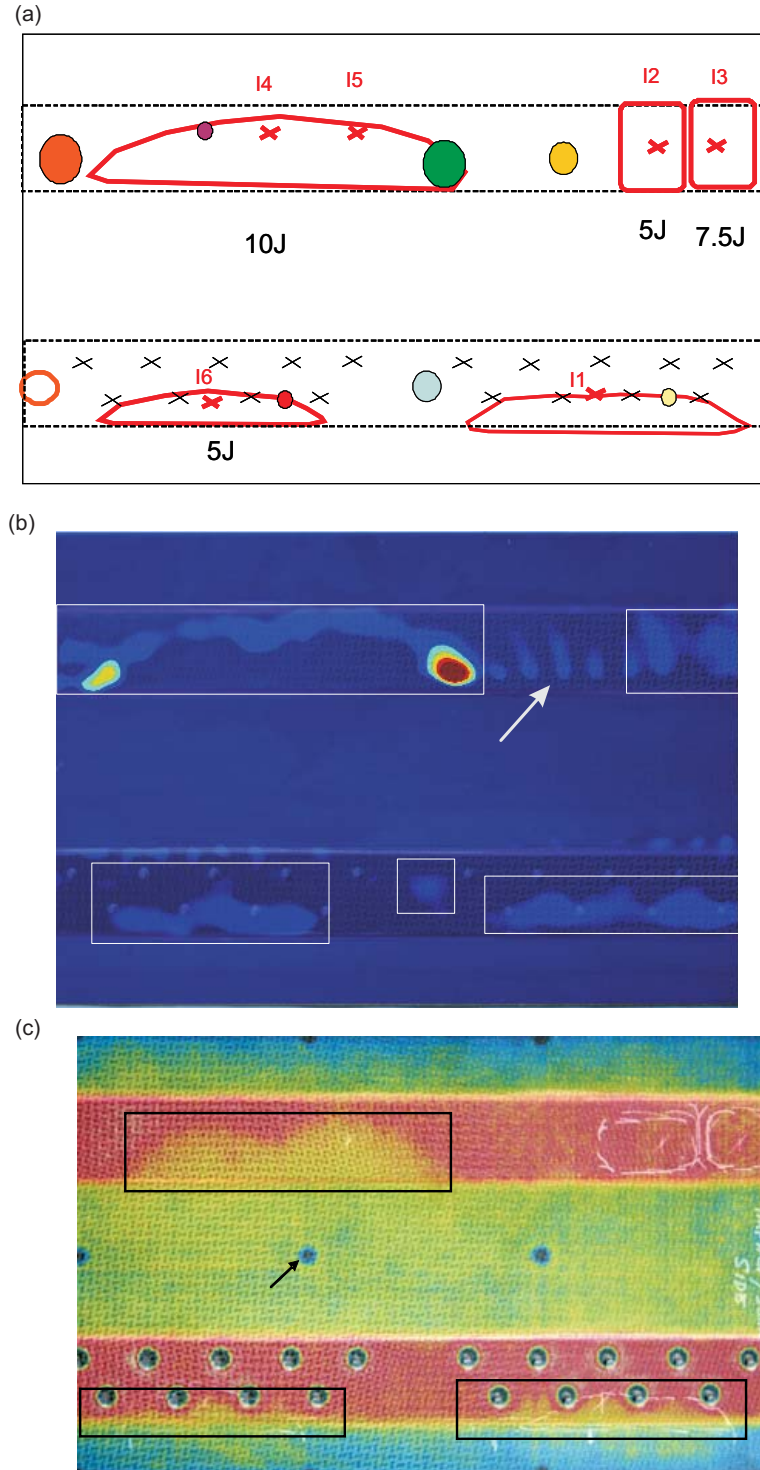
boxes. Insonification was applied to the central left of the specimen. The impact damage caused by I1, I4, I5 and I6 was detected. Frictional and/or anelastic heating occurs around the edges of the impacts as shown by the outline of the impact damaged regions of I4 and I5. This also suggests that the impact damage has caused large air gaps, and this is confirmed by the FT results (Figure 9(c)), which indicate a larger thermal resistance within the outlined region. The strong localised thermal signature at the bottom right of the impact damage and region corresponding to I4 and I5 coincides with the position of one of the vaseline inclusions. Indications of impacts I2 and I3 and the centrally positioned vaseline inclusion in the lower flange (flange 1), located at the centre of the fastener region (highlighted by the box) are also evident in the ST result. It should be noted that these indications also exhibit a periodic modal signature which contributes some uncertainty to the identification of these as defects. The reason that the other vaseline inclusions were not detected may lie in the fact that, like Teflon, vaseline may hinder the production of frictional heating during insonification. Thermal indications were also observed along the upper edge of the riveted flange panel, indicating frictional heating between the flange and the skin. Also, indicated by the arrow, are vibrational mode patterns due to anelastic heating.

**Figure 9:** (a) Damage map, (b) ST result (PCT<sub>3</sub>) and (c) FT result of specimen 1. The results shown in (b) and (c) are of the respective thermographs which have been superimposed with a photograph of the panel. In (a) the coloured circles correspond to the vaseline contamination in the bondline, red crosses indicate impact fractures and areas marked by the red outline indicate damage disclosed by C-scans. In (b) the arrow indicates vibrational mode patterns due to anelastic heating. Note that the blue circles in (c) (an example of which is indicated by the arrow) are markers used for alignment of the thermographic images.

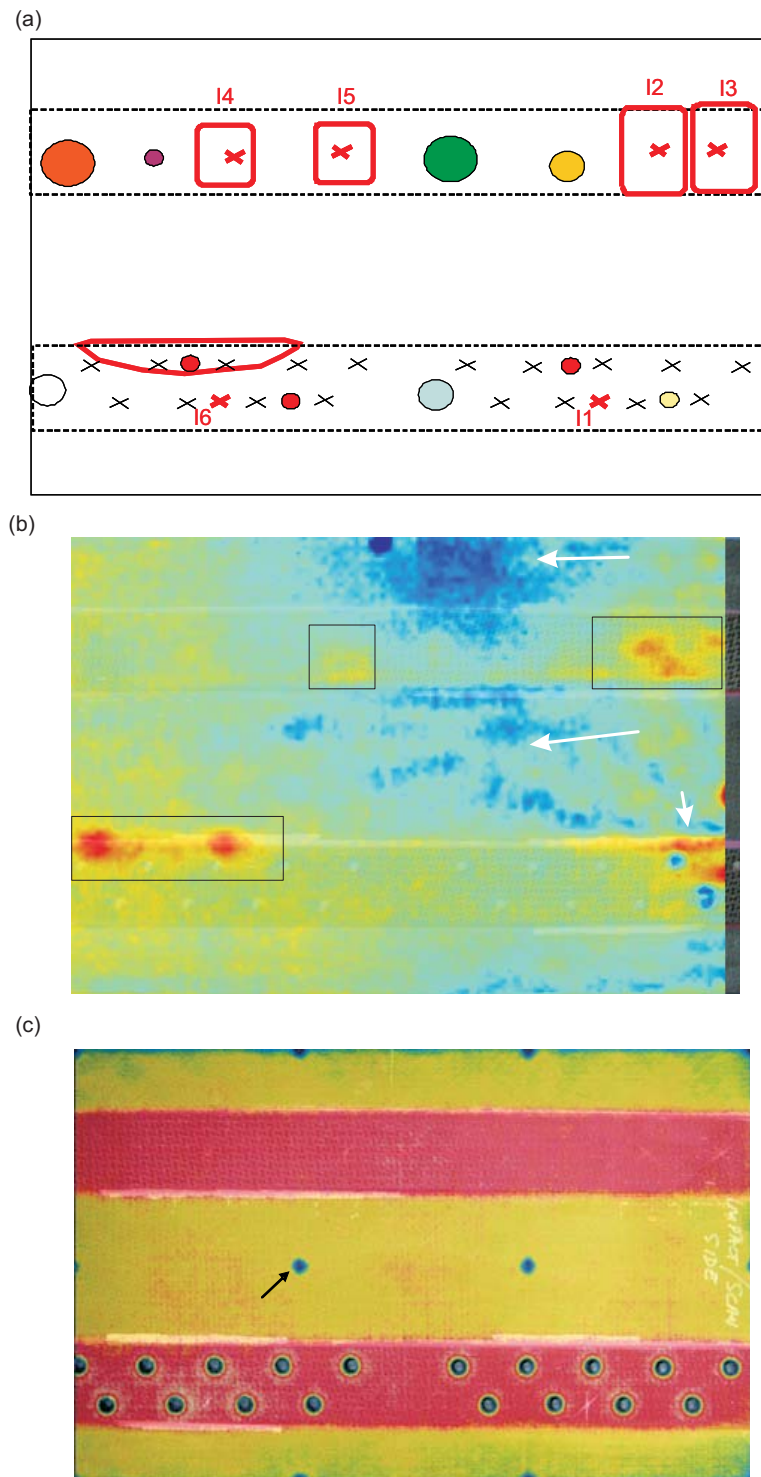
In Figure 10(b) the ST result for specimen 2 indicates significant damage in the I6 impact region. The insonification was applied to the central right of this specimen. The thermal signatures correspond to the edge of the damage area, which is, evidently, in compression. Faint indications of the impact damage caused by I2, I3 and I5 were detected, however these are difficult to distinguish from the modal vibration patterns (indicated by the arrows). In a blind test it would be difficult to conclusively determine that these areas corresponded to damage. None of the vaseline inclusions were detected, partly for the reason stated previously, and also because the detection of defects is hindered by the Cu mesh/ fibreglass finish, which acts to diffuse heat in the lateral or in-plane direction. The extra plies also increase the diffusion length, resulting in a reduction in the thermal signature. FT was unable to detect any damage or inclusions (Figure 10(b)).

**Figure 10:** (a) Damage map, (b) ST result (phase) and (c) FT result for specimen 2. The results shown in (b) and (c) are of the respective thermographs which have been superimposed with a photograph of the panel. In (a) the coloured circles correspond to the vaseline contamination in the bondline, red crosses indicate impact fractures and areas marked by the red outline indicate damage disclosed by C-scans. In (b) the arrows indicate vibrational mode patterns due to anelastic heating. Note that the blue circles in (c) (an example of which is indicated by the arrow) are markers used for alignment of the thermographic images.

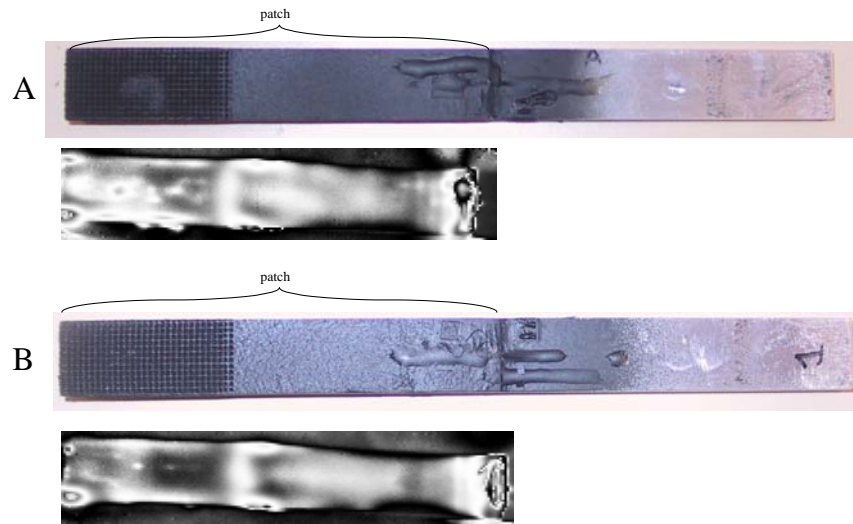
Figure 13 shows photographs of sides A and B of the lapjoint and the corresponding PPT results for each side during insonification. The PPT results for both sides clearly show a bright vertical band mid way through the patch. This corresponds to where the specimen was gripped in the tensile machine and is likely to indicate localised sub-surface damage caused by the grips. On the far right of both thermographs there is an indication of a strong heat source corresponding to the disbonded patch edge. Heat production occurs due to frictional heating between the disbonded patch and the aluminium face. There are

**Figure 13:** From top to bottom, photograph of lapjoint side A, corresponding PPT result, photograph of lapjoint side B and its corresponding PPT result.

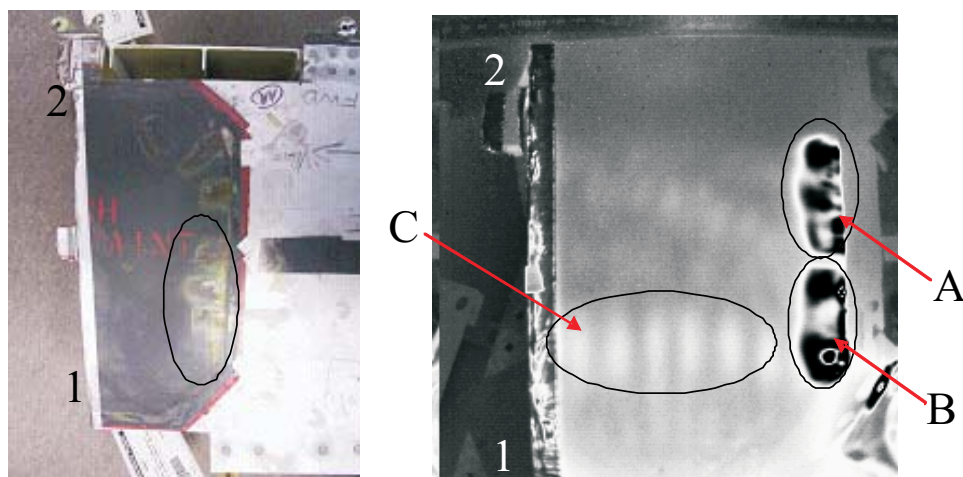
**Figure 15:** (a) Photograph of the LWS fragment 12W951A1 indicating region of interest. (b) Raw ST image showing darkened regions indicating elevated heat production and possible disbands.

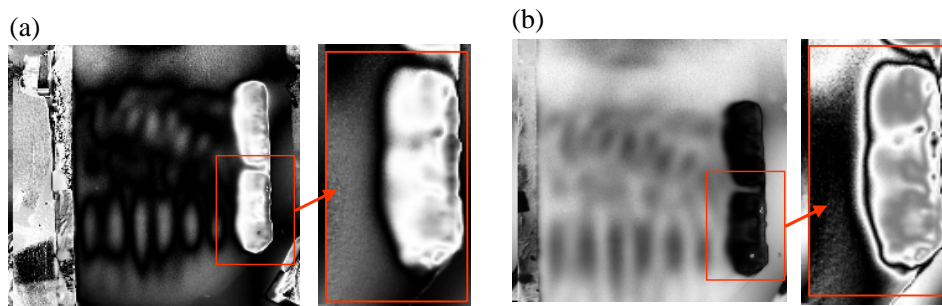
**Figure 16:** (a) PPT and (b) PCT results elucidating the disbond in regions A and B. Different grey scales were used in order to accentuate the flaw regions.

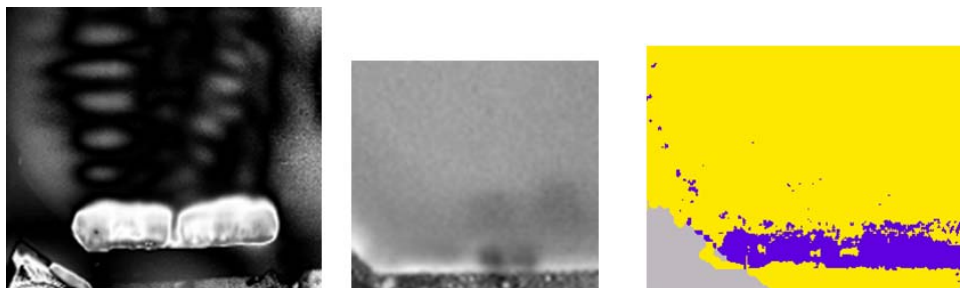
**Figure 17:** Comparison of sonic PPT, flash PPT and C-scan results, respectively showing the disbonds in regions A and B.

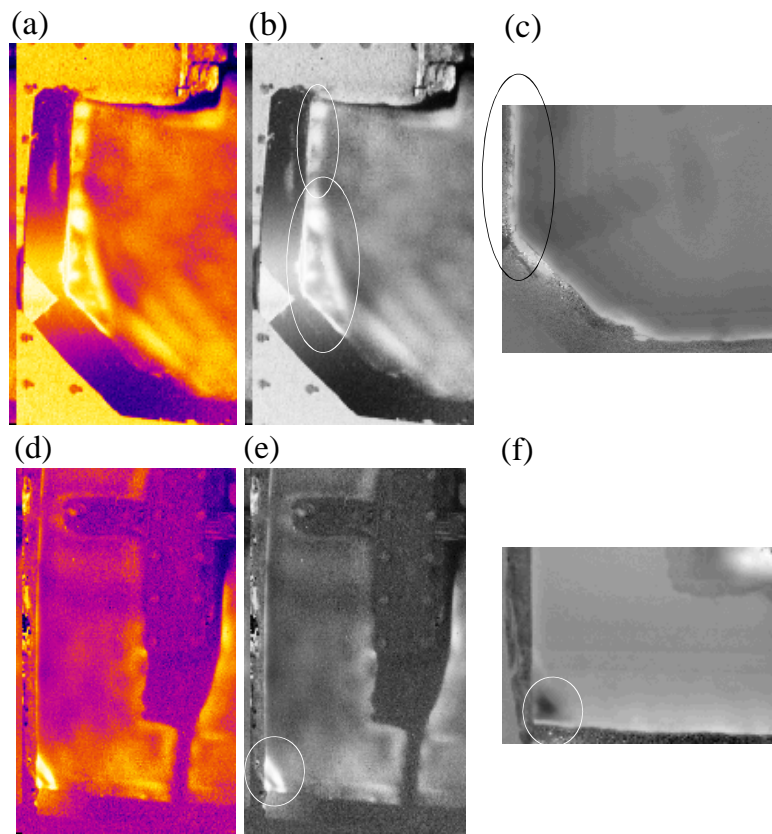
A photograph of the other LWS fragment, 12W951X, is shown in Figure 18 and Figure 19 shows the PCT results (a, b, d and e) and corresponding flash thermographs (c and f) for regions D and E, as indicated. It is noted that a non-grey colour map is used in this case merely to accentuate indications, and does not indicate relative temperature; that is whether a region is hotter or colder. The PCT results show clear indications of disbonding (circled) which are not as strong in the FT results (c and f). Once again the spatial detail is superior in the ST results.

**Figure 19:** (a) and (b) are the sonic  $PCT_2$  results of region D and (c) the corresponding flash PPT result of the same region (circled) and (d) and (e) are the sonic  $PCT_2$  results of region E and (f) the corresponding flash PPT result.

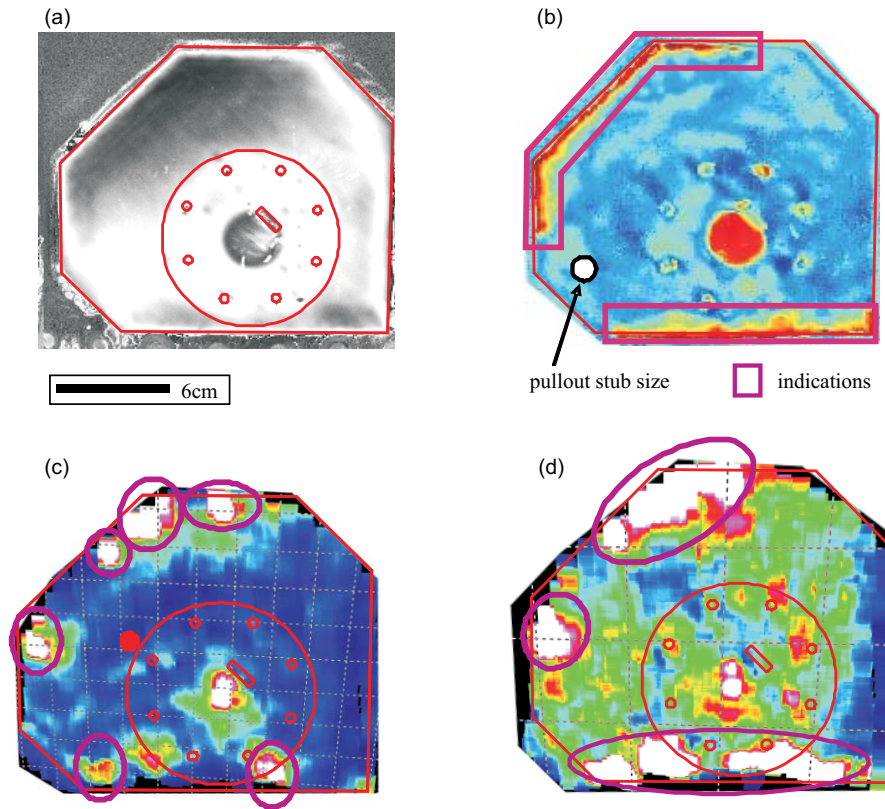
**Figure 22:** Results for (a) flash PPT (b) sonic  $PCT_2$  (c) BaNDIcoot with peak index set at 4% and 9-15 kHz and (d) BaNDIcoot with peak index set at 2% and 25-35 kHz. The defect indications are circled in pink. An example of the pullout stub size is shown in (b) as a white circle.

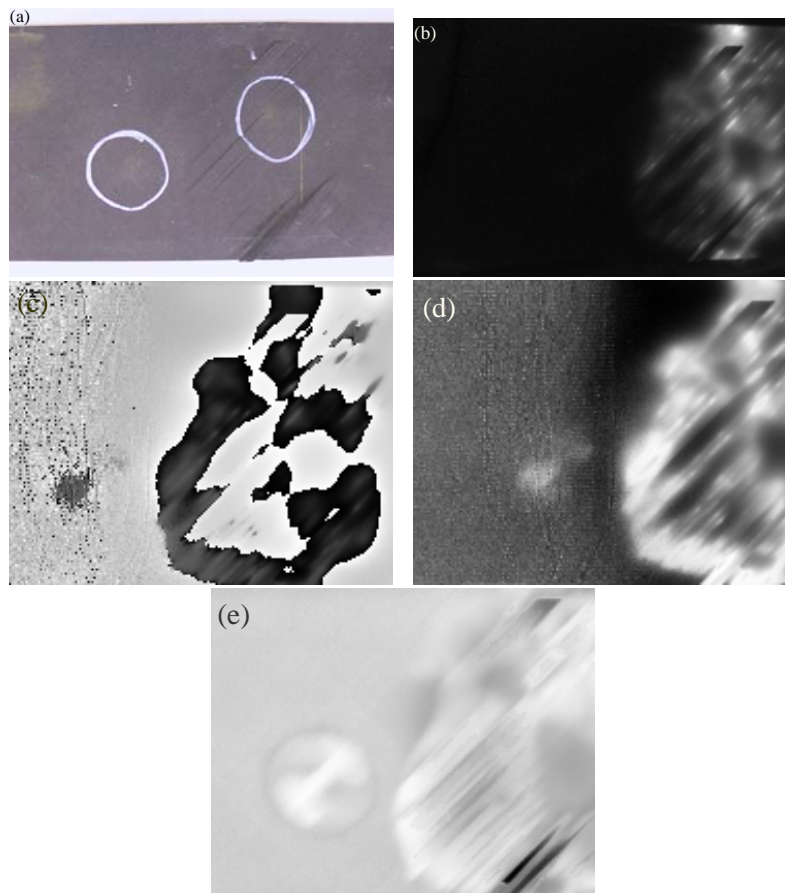
**Figure 23:** (a) Photograph of the impact damaged regions of the composite specimen; impact regions are indicated by the circles. ST (b) raw, (c) PPT and (d) PCT<sub>2</sub> results and (e) flash PPT result of the impact damaged regions of the composite specimen.

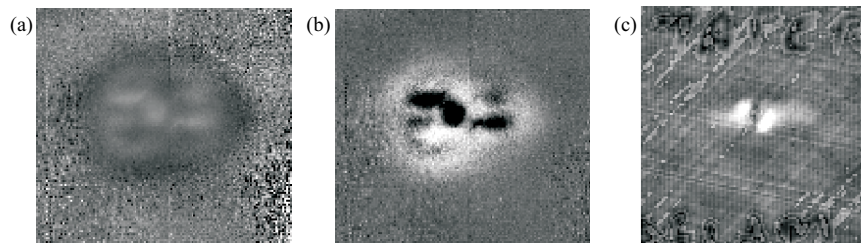
**Figure 25:** The ST (a) PPT and (b)  $PCT_3$  results and the (c) flash PPT result of the impact damaged region of the composite specimen.

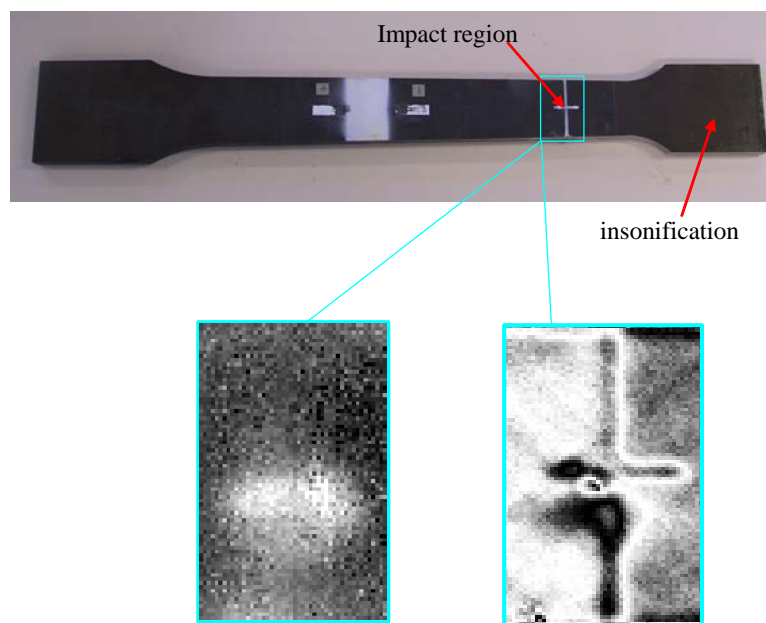
**Figure 26:** Photograph of the step lapjoint specimen showing the impact region and the insonification point. The bottom left image is the sonic  $PCT_2$  result and the bottom right image is a flash PPT result of the damaged region.

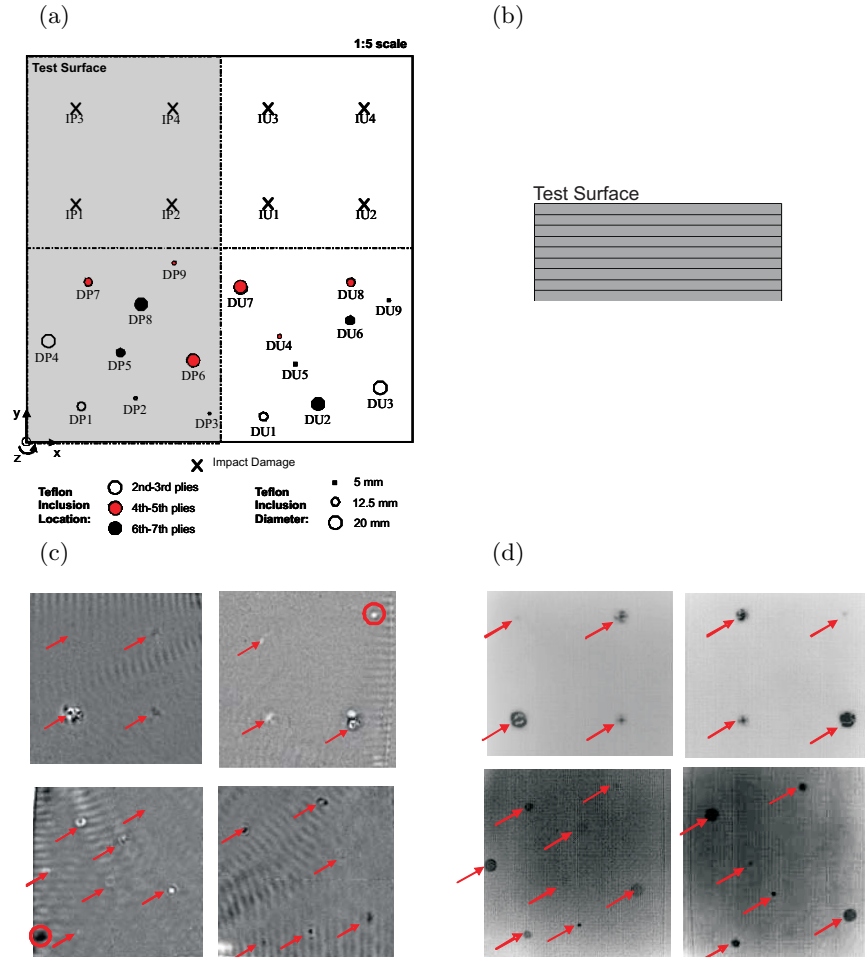
map. The detected damage is highlighted by the red arrows. DP1, DP4, DP5 and DP9 show very faint thermal indications and DP6 shows a clear indication in comparison to the FT of the same defect. This may indicate higher contact stress of the faces of this defect compared to others. The circled regions, at the top right and bottom left of the thermograph, show thermal indications from lead targets situated on the back of the specimen. Based on the rule of thumb described in section 3.2 and the known skin thickness given the diffusion length, all disbond defects should have been observable. None of the 5 mm diameter inclusions and some of the 12.5 mm inclusions were detected using ST, whilst all but DP3, DU6 and DU9 were detected using FT. As a general rule a Teflon insert is a poor approximation to a disbond for a ST procedure since the coefficient of friction is low between the Teflon and the laminate, thus producing a lower amount of heating than would be expected for a real disbond. A closer examination of the ST images of the inclusions that were detected reveals a ring like appearance, similar to that observed for impact damage. This suggests that anelastic heating of the composite due to higher strains at the edges of the inclusions may be contributing significantly to the thermal signature observed.

**Figure 28:** (a) Damage map, (b) profile image of layup, (c) sonic and (d) flash thermographs showing the four quadrants of specimen 1A and the corresponding damage locations. The 'U' and 'P' refer to the damage locations on the unpainted and painted side of the specimen, respectively. (Specimen layout courtesy CRC-ACS.)

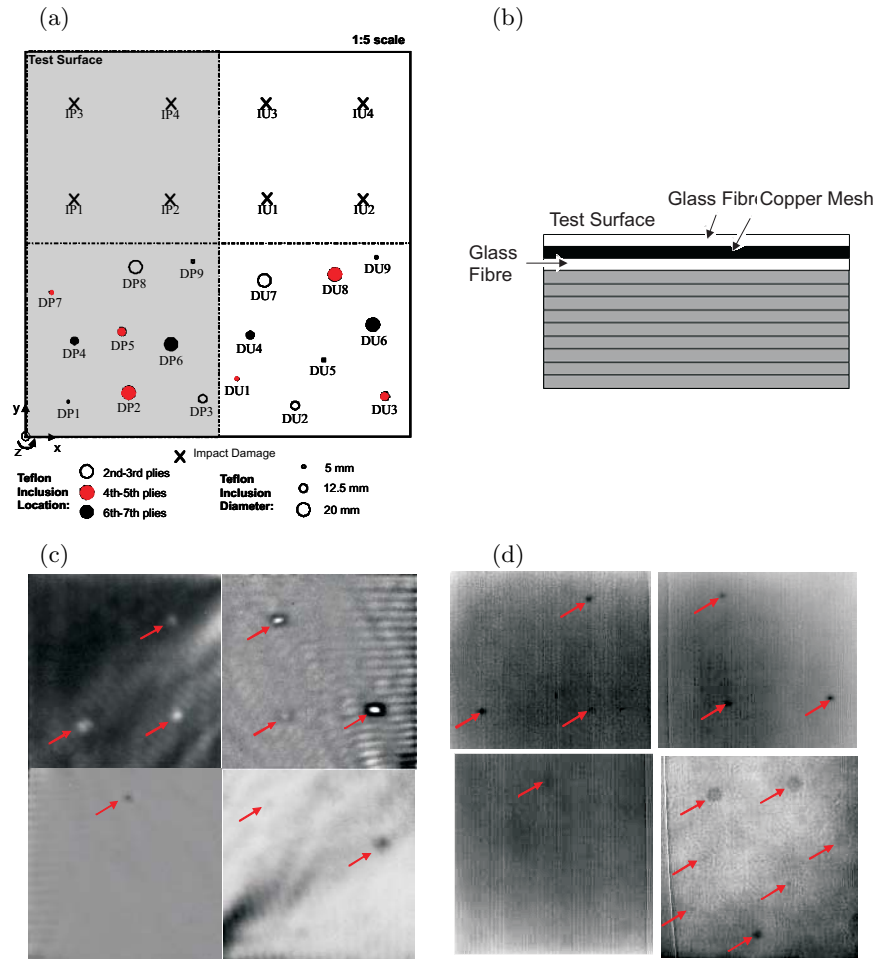
Figure 29 shows the ST and FT results for specimen 1B and the corresponding damage map. The presence of the glass fibre/ copper mesh layers significantly reduces the effectiveness of both ST and FT. This can be attributed to a number of factors. Specimen 1B is 3 plies thicker than specimen 1A, thus increasing the defect depth, resulting in a fainter signature. Also, if only the edges of the inclusions are contributing to the heating, as was speculated for specimen 1A, the area of the defect which contributes to heating is smaller than the defect itself, reducing its detectability. The existence of the copper mesh layer also has a deleterious effect by increasing the amount of lateral diffusion. The effect of the copper mesh on the thermal signature can be observed in the impact damage signatures of the two specimens (with and without mesh). The sonic thermographs of the impact damage in specimen 1A shows distinct detail, particularly for the high energy impacts (12.5 J) of IP1 and IU2. In comparison, the equivalent impacts in specimen 1B are detected, however the signatures appear smeared, and lack the detail seen for specimen 1A.

**Figure 29:** (a) Damage map, (b) profile image of layup, (c) sonic and (d) flash thermographs showing the four quadrants of specimen 1B and the corresponding damage locations. (Specimen layout courtesy CRC-ACS.)

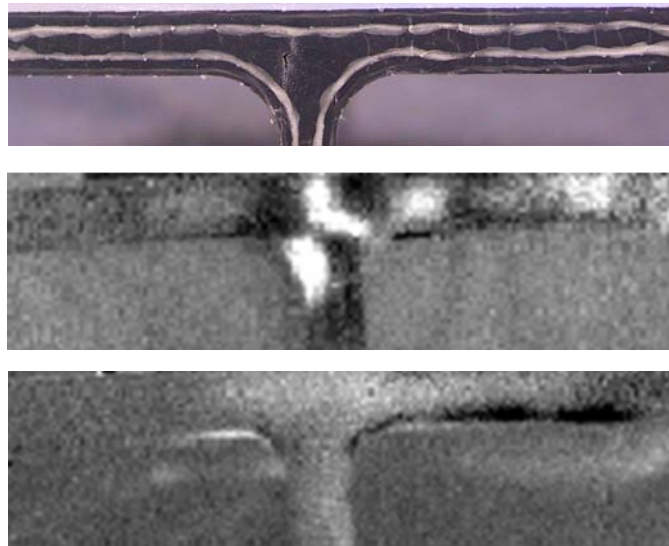
**Figure 35:** Photograph of region B (top) and the sonic  $PCT_3$  results for the damaged area of the I-beam (middle) and the reference specimen (bottom).

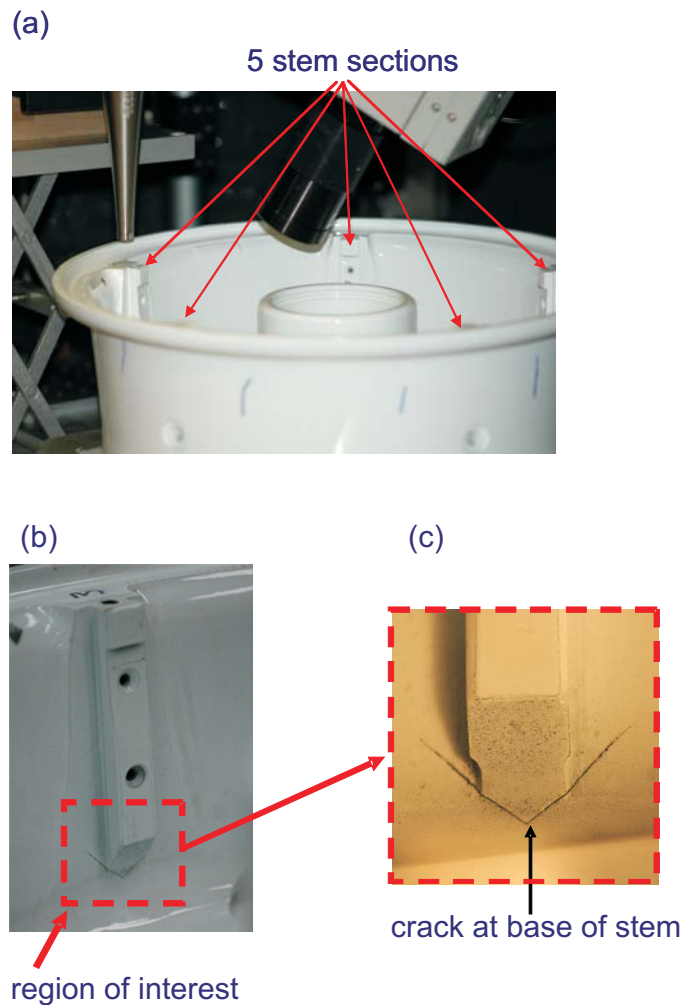
**Figure 42:** Photograph of (a) F-16 main wheel rim, the five stems to be inspected are indicated, (b) one of the stems, with the region of interest highlighted by the box and (c) a close up view of the area to be inspected. For this case a visible crack is observable.

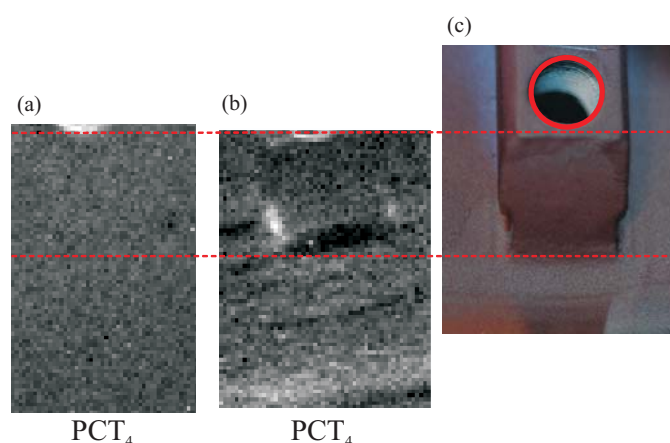
**Figure 45:** PCT results corresponding to insonification positions (a) 1 and (b) 2 of stem 2. (c) shows a photograph of the region. The parallel lines are used to align the thermal images with the photograph.
